## Damage assessment of the May 31st, 2019, Talcahuano tornado, Chile

On May 31st, 2019, a tornado hit the city of Talcahuano, Chile, generating significant damage to structures and leaving one person dead. The objective of the present paper is to report on damage to structures in Talcahuano. A preliminary survey was performed by the Municipality of Talcahuano and covered the entire affected area with a cellphone web application used to report the severity and distribution of damage. A more comprehensive damage survey was conducted in the *Brisa del Sol* neighborhood in the *Medio Camino* area by the UCSC team to assess the damage distribution within an area with well-defined and homogeneous building typologies. The results of the field surveys showed that the tornado behaved as a skipping tornado and that most damage to houses consisted of wall opening damage, roof sheathing failure, and wall cover removal (EF0), followed by partial roof removal (EF1). It was noticeable that self-built systems (house additions) were more damaged than original houses, which may be explained by the fact that such structures do not always meet minimum building standards. It is recommended that field

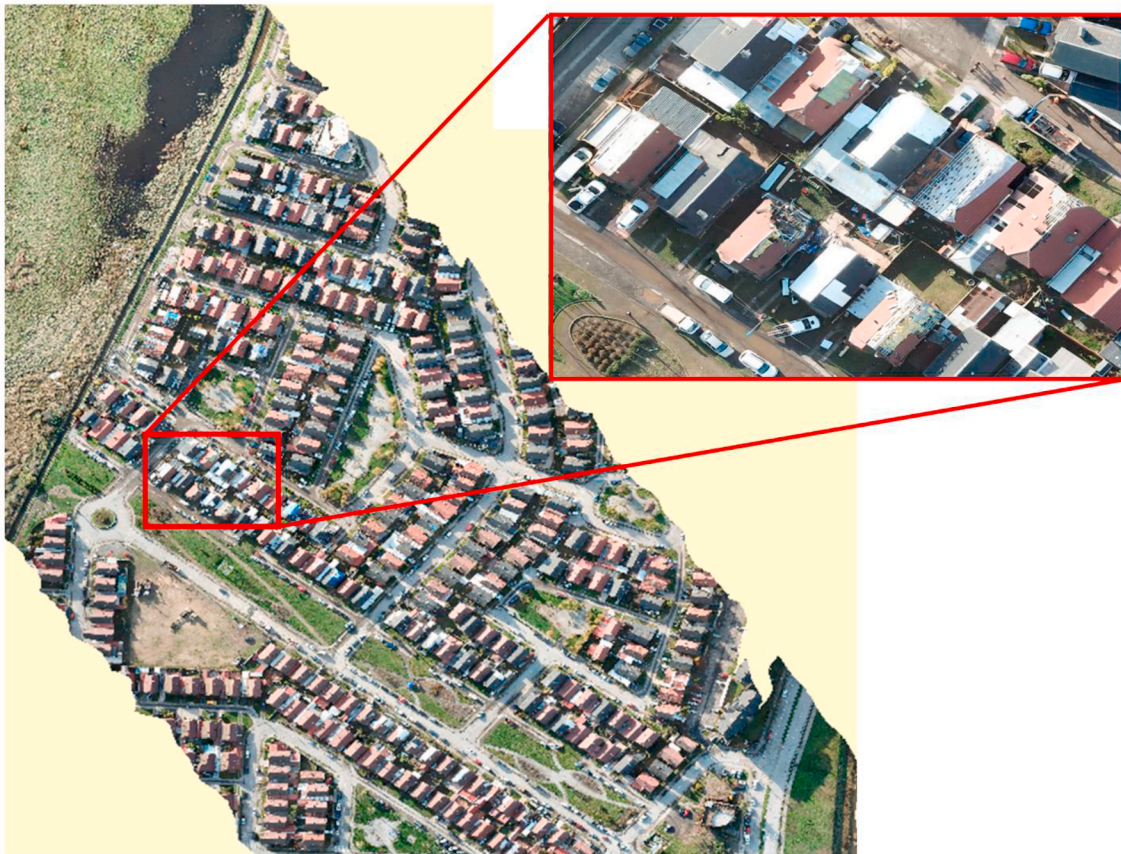
Fig. 2. Example of aerial image along tornado's path in the *Brisa del Sol* neighborhood, Medio Camino area.

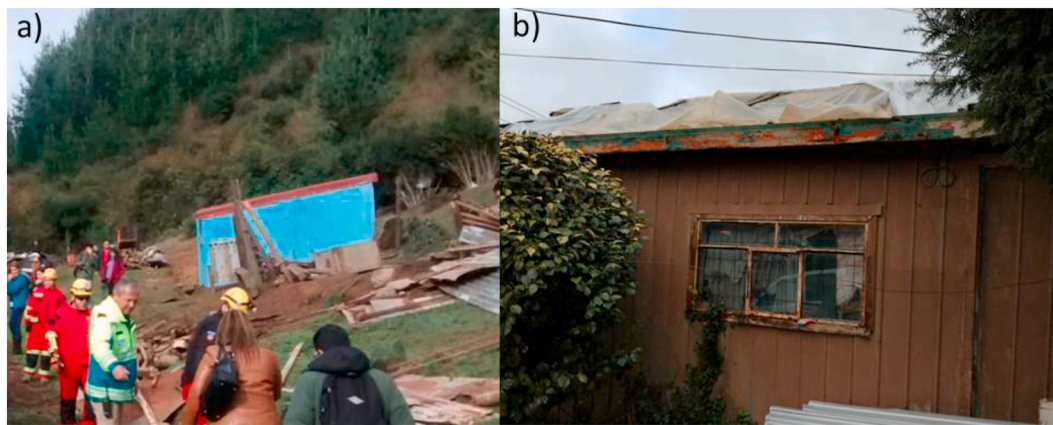
In the *Cerros* and *Tumbes* areas, 47 houses were reported damaged, mainly in the *Cerro Buenavista* neighborhood (14 damaged houses). Fig. 3 shows damaged houses in these areas. From Fig. 3-a, it is possible to observe the only damaged house in *Caleta El Soldado*. This house was

made of lightweight materials such as timber and corrugated metal roof sheets, which is typical of traditional or outdated construction. The damage was not total, despite the type and material of the structure. Hence, it may be inferred that the wind velocity was not very strong when the tornado reached land. Fig. 3-b shows a representative house in *Cerro Buenavista*. This house was protected against the rain by a plastic cover since the wind removed the roof. In general, typical damage in this zone was concentrated in the wall opening (windows) and roof sheathing failure categories; therefore, the damage in this area was mainly classified as moderate (45%) and major (45%), with 5 houses reported as destroyed.

Fig. 3. (a) Light structural damage in *Caleta El Soldado* and (b) the *Cerros* neighborhood.

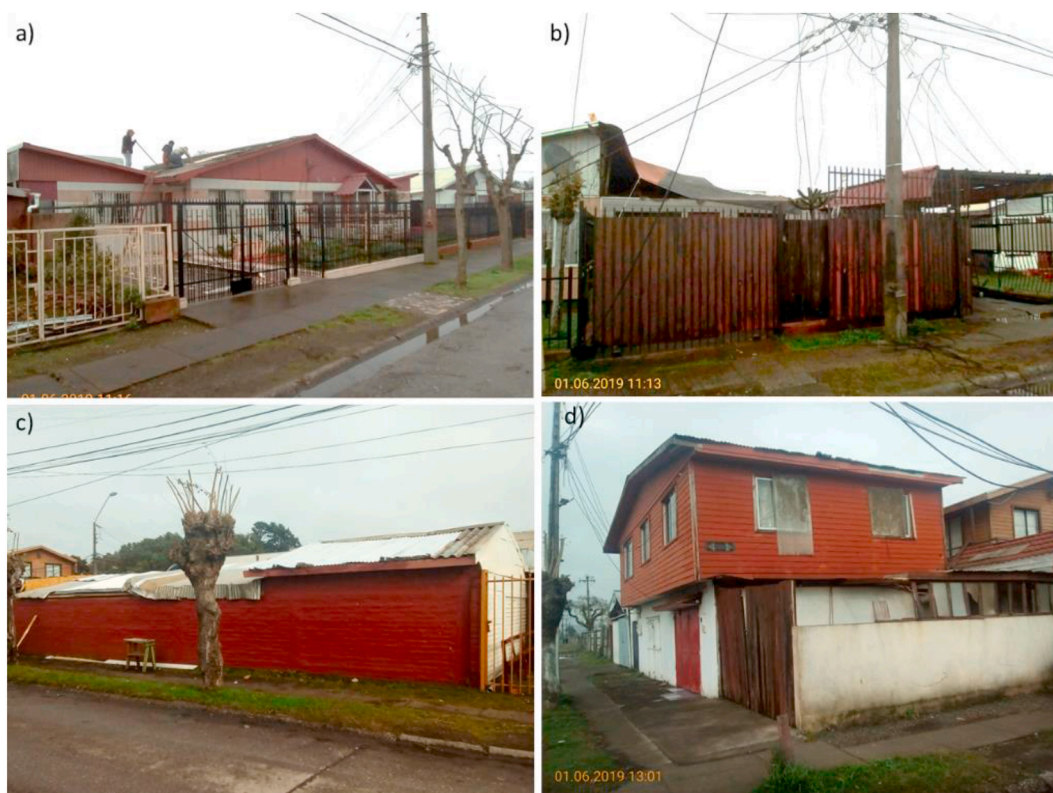
Similarly, 17 buildings were reported damaged in the *Higuera* area. Most of the damage was observed in the *21 de Mayo* (7 damaged houses) and *Corvi* (3 damaged houses) neighborhoods (see Fig. 1). In this area it is possible to find one- or two-story timber houses. Fig. 4 shows typical houses and representative damage. Fig. 4-a shows houses with the roof sheathing uplift failure, typical for this entire affected area. As seen in the figure, this house was being repaired at the moment of the field survey (one day after the event). Fig. 4-b shows a structure, half of which experienced partial roof removal. Fig. 4-c and 4-d show houses with roof sheathing and wall opening failures, respectively. The observed damage in this sector was also classified as moderate to major (76%).

Fig. 4. Damage observed in the *Higuera*s area. (a) House with partial uplift of roof sheathing, (b) structure with partial roof removal, (c) house with roof sheathing failure, and (d) house with wall opening damage.

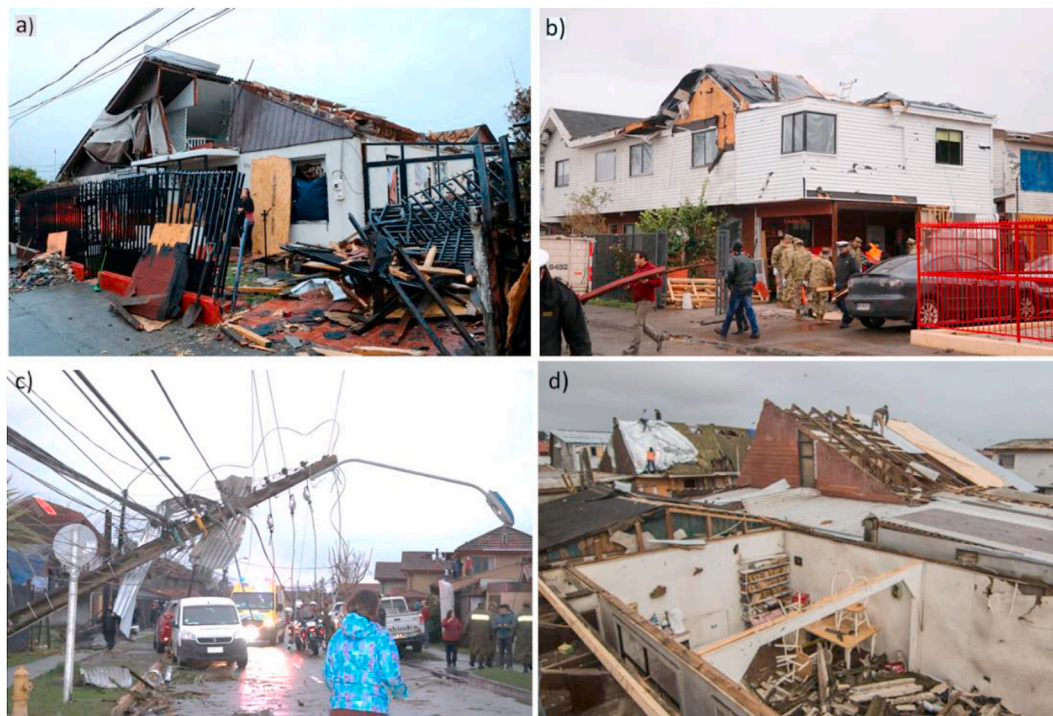
sheets replaced the fiber cement planks. Fig. 5-a and 5-b show an example of the original and modified houses in the *Cruz del Sur* neighborhood, respectively. In both cases, it is possible to observe broken glass in windows, as well as wall sheathing and partial roof removal. It can also be observed in Fig. 5-a that steel fence panels were removed due to wind action.

Fig. 5. Damage observed in the Salinas area. (a) *Cruz del Sur* neighborhood, (b) *Cruz del Sur* neighborhood, (c) *Jaime Repullo* neighborhood, and (d) *Huertos Familiares* neighborhood.

built on confined masonry and upper floors constructed on lightweight steel framing. In general, these structures experienced less damage (wall and roof sheathing failure), although severe damage to utility poles was observed, as shown in Fig. 5-c.

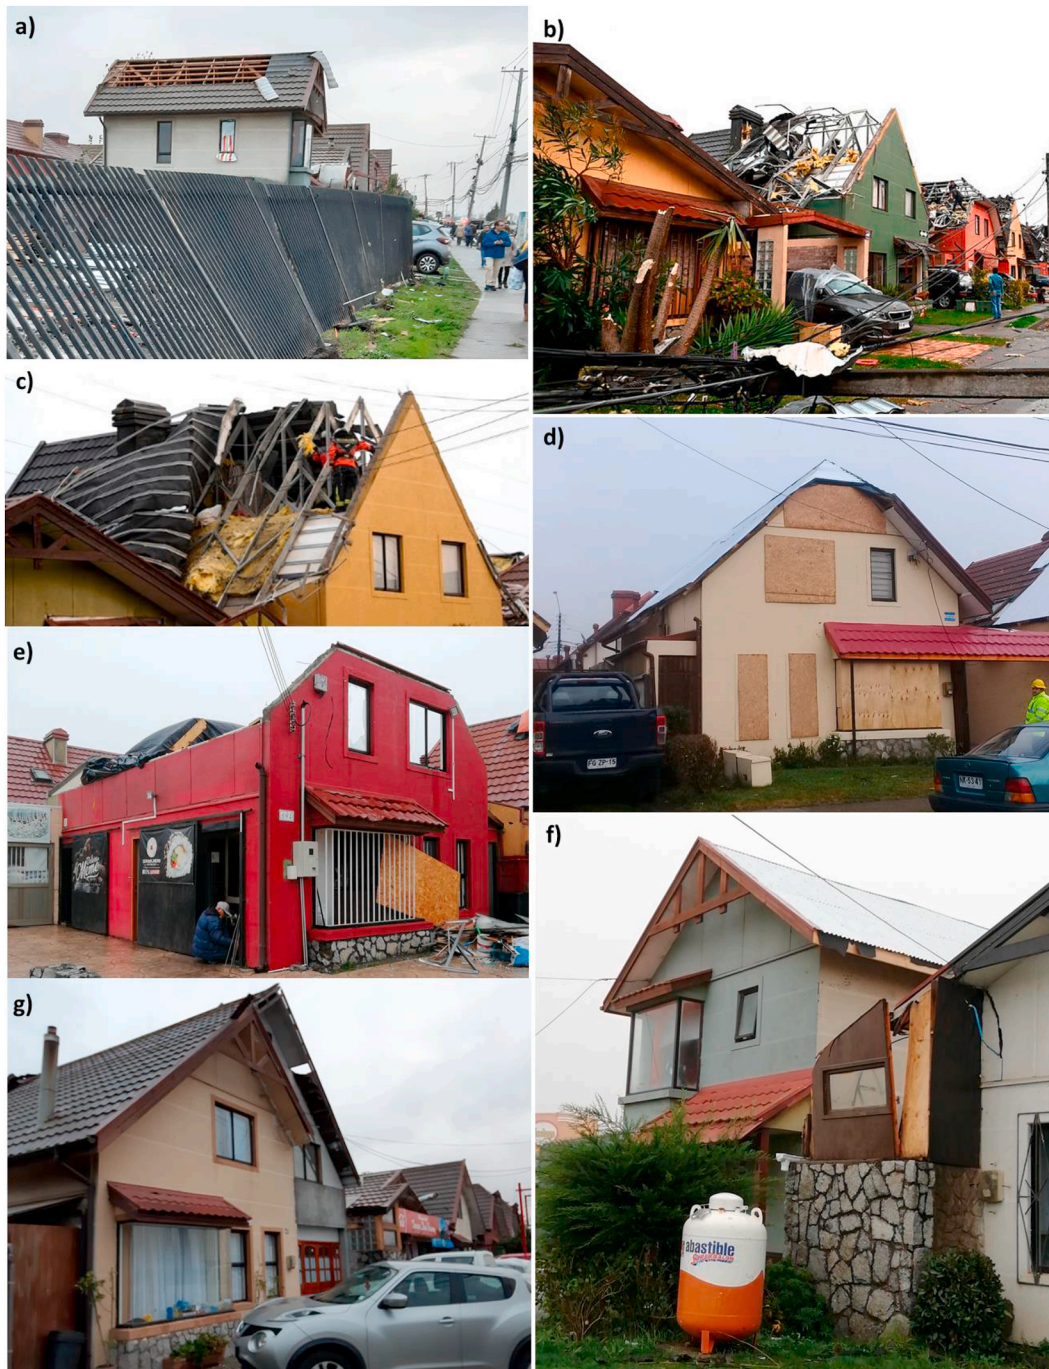
In the *Medio Camino* area, only the *Brisa del Sol* neighborhood was affected, including the *Marina del Sol* Casino. This neighborhood is located west of *Carriel Sur* airport (see Fig. 1). According to the FIBE forms, a total of 205 structures were reported damaged; 14 were classified as destroyed, 62 as severely damaged (full roof removal and extended damage on external walls), and 89 as moderately damaged (broken glass, partial roof removal and light damage to walls). This neighborhood is a relatively new development – composed mainly of two-story houses with three well-standardized building models – that offers a good opportunity for assessing the damage severity distribution. These houses were built on a ground floor made of confined masonry and an upper floor made of lightweight steel framing. In addition to the houses, a group of four five-story reinforced concrete buildings, which experienced mostly roof sheathing failure, was also affected (not reported in this paper). A directional procedure method for design of the main wind force resisting system is applied in Chile, which is similar to the method used in Ref. [14]. Fig. 6-a, 6-b, 6-c, and 6-d show typical roof sheathing failure of this type of structure. However, in some cases the roof deck was removed together with the roof joist (Fig. 6-b and 6-c), while in other structures glass broke in doors and windows (Fig. 6-d). Few cases of severe damage such as full roof removal and wall openings were observed (Fig. 6-e). The damage to house additions such those shown in Fig. 6-f and 6-g is interesting. While there was no or minor damage to the original houses, the additions experienced partial uplift of the roof deck (Fig. 6-g) or partial wall collapse (Fig. 6-f). In general,

these additions were built without regard for building standards or professional advice and with materials that differed from those used in the original house.

**Fig. 6.** Affected structures in the *Brisa del Sol* neighborhood. (a) Roof sheathing failure, (b) roof sheathing and joist failure, (c) roof sheathing and joist failure, (d) roof sheathing and wall opening failure, (e) complete roof failure, (f) partial wall collapse of house addition, and (g) roof deck uplift of house addition.

is shown in Fig. 6-e. It is important to mention that EF0 and EF1 are related to damage to non-structural components, which are designed under conditions other than tornado loads. It was observed that the primary reason for damage was failure of anchor of non-structural components. In addition, it is worth mentioning that the house shown in Fig. 6-e had been modified for conversion into a local shop, with two large gates added to the ground floor. Subsequently, suction forces may be increased compared to neighboring structures.

houses (see Fig. 6-f and 6-g).

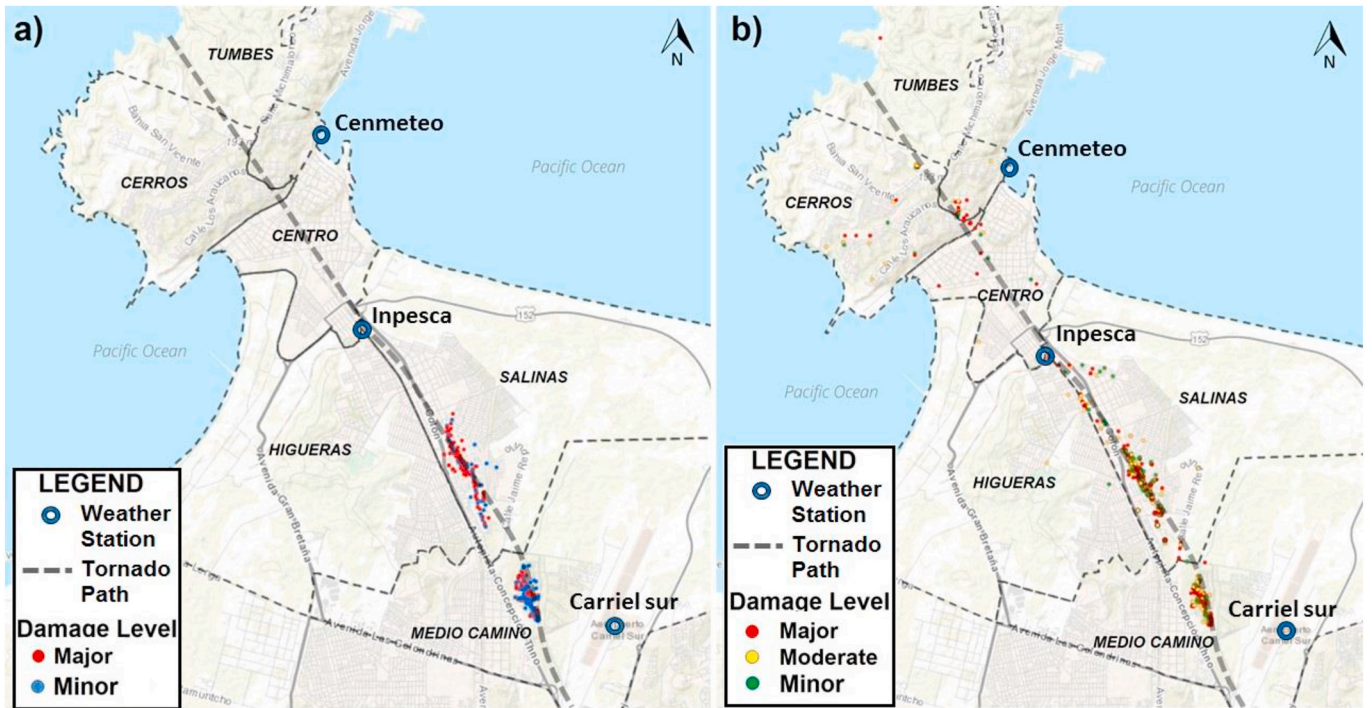
This section describes the general damage distribution obtained from the preliminary field survey. While the FIBE form survey was applied throughout the area, the cellphone survey was applied to the most affected areas only. Fig. 7 shows a general view of the damage observed in Talcahuano along the tornado path. A fair level of agreement can be observed between the two damage distribution maps presented in Fig. 7, despite the different damage scales used in the surveys. It can be seen that major damage levels are concentrated along the tornado path.

In general, Fig. 7-b shows that the most affected areas are *Salinas* and *Medio Camino*, while *Centro* and *Higueras* each presented fewer than 20 damaged houses. The *Tumbes* area did not present any damage, except for the affected house in *Caleta El Soldado*. It is interesting that houses in areas neighboring the INPESCA weather station, which is located along the tornado path and recorded a maximum wind velocity of 101 km/h, did not present significant damage. Therefore, most of houses in these neighborhoods were able to resist the wind load despite being old and made of timber (see Fig. 4). However, the tornado intensity increased as it moved southeast. Damage to houses consisted mainly of wall opening and roof sheathing failure and wall cover removal, which is consistent with EF0 [3]. However, damage such as partial roof removal was also observed in several neighborhoods (*Jaime Repullo*, *Huertos Familiares*, and *Brisa del Sol*), which corresponds to EF1. Very few structures, such as the ones shown in Fig. 5-d and 6-e, experienced full roof removal or partial wall collapse (EF2). In addition, it was observed that recent structures (built after the 90s) performed better than old structures (built in the 70s and 80s) in the *Salinas* area. While the former group consists of houses made of confined masonry and lightweight steel framing with no modifications, the latter homes are made of timber with significant modifications to the original structure. In a similar manner, houses in the *Brisa del Sol* neighborhood, which are also made of

Fig. 7. Spatial damage distribution maps. a) Results from quick initial assessment with cell phones. b) Official survey with FIBE forms.

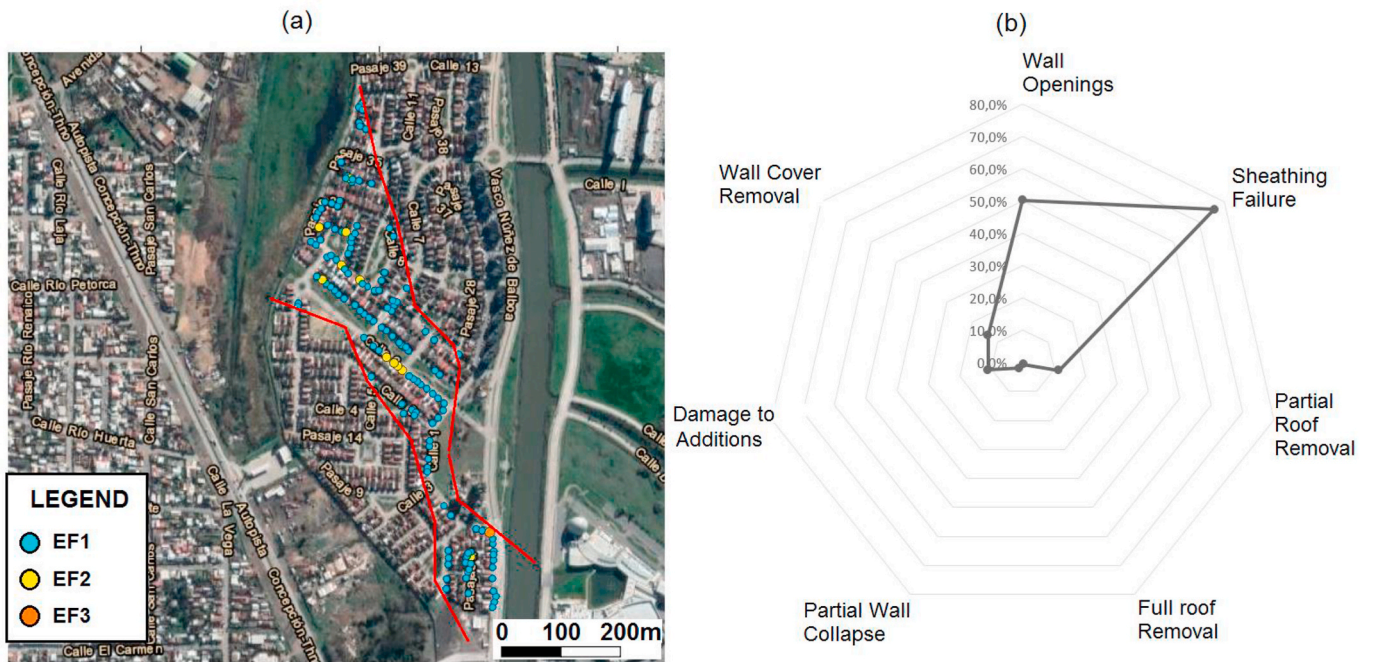
The comprehensive damage assessment conducted by the UCSC team included a total of 366 houses, of which 146 were found to have some degree of damage. The results of this analysis are presented in Fig. 8. Fig. 8-a shows the area affected by the tornado and the severity of the damage, 91.8% of which is classified as EF0, with only 11 houses undergoing damage classified as EF1 (7.5%) and just one – the house that suffered full roof removal – damage classified as EF2 (0.7%); this house

Fig. 8-b presents the damage distribution according to the type of damage observed during the survey, with roof sheathing and wall opening failure being the most common problems, followed by wall cover removal, partial roof removal and damage to additions. In general,

Fig. 8. (a) Damage surveyed in the *Brisa del Sol* neighborhood. Red line indicates the width of the tornado path. (b) Relative distribution of observed damage.
